TEST REPORT: P09182-T02

Description of assignment: Abrasion tests on corrugated pipe

Specimen designation	Received on	Specimen prepared by	Description of the test specimen according to the client's specifications
IKT			
L8761-3	15.10.2024	Manufacturer	Polyethylene (PE) pipe DN/OD 315, SN 10, UNI EN 13476-3 Product name: Magnum Performante

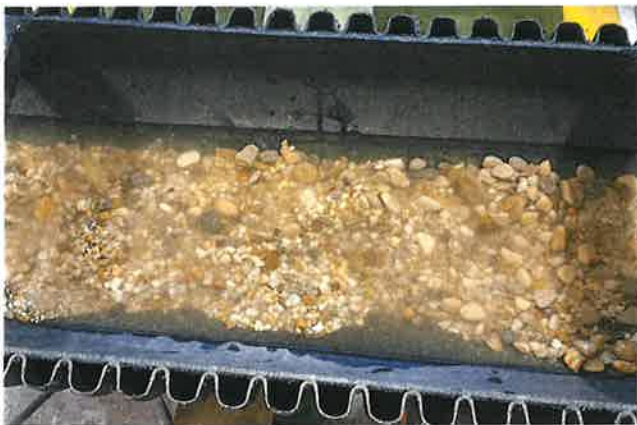
Figure 1: Sand/gravel/water mixture in the half shell before testing

With reference to DIN EN 295, Part 3, a 5,0 kg quantity of a mixture of sand and gravel (natural, non-crushed round-particled quartz gravel) is put into the pipe half-shell. Water is then added up to a depth of 38 ± 2 mm.

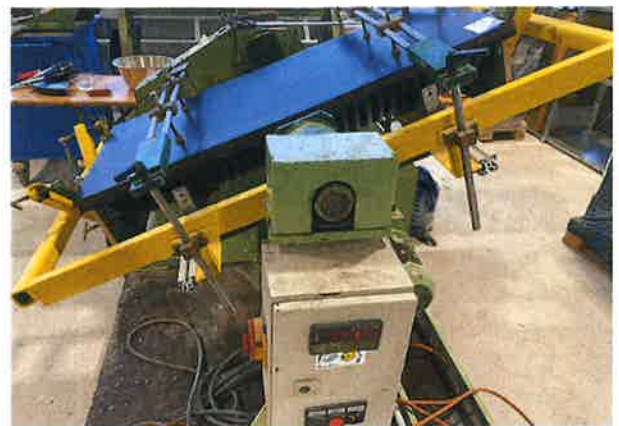
Figure 2: Testing in the Darmstadt tilting apparatus

The specimen is alternately tilted by $\pm 22.5^\circ$ in its longitudinal direction (20 cycles per minute), causing the movement of the mixture of sand, gravel and water to generate an abrasive action. The specimen is removed from the apparatus after 100,000 load cycles and the abrasion on the base line is measured. The test specimen is then reinstalled in the tilting apparatus and a further 100,000 load cycles are carried out. After a total of 200,000 load cycles, the test specimen is then removed and measured again.

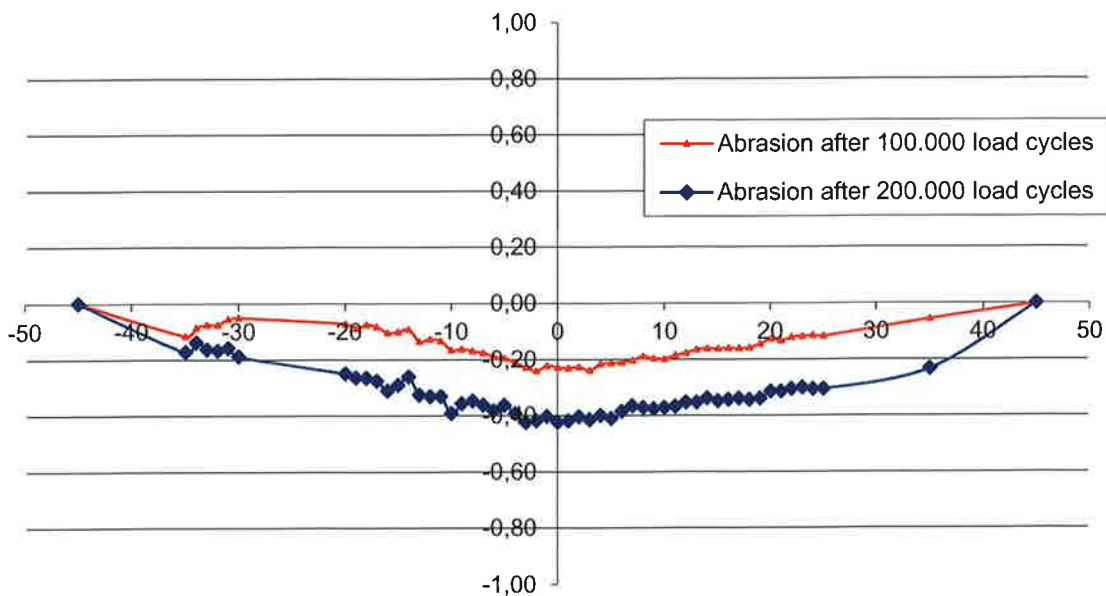
Figure 3: Abrasion after 100,000 and 200,000 load cycles

Measuring the abrasion in the base of the half-shell with a measuring gauge (accuracy better than $\pm 0.03 \text{ mm}$) using a measuring bridge shows a slight abrasion of the base. The measured values after 100,000 and 200,000 load cycles are shown in the graph in Figure 3 for the measuring points over the length of the pipe. The analysis of the measured values resulted in an average abrasion of 0.15 mm after 100,000 cycles and of 0.32 mm after 200,000 cycles (s.a. Table 1).

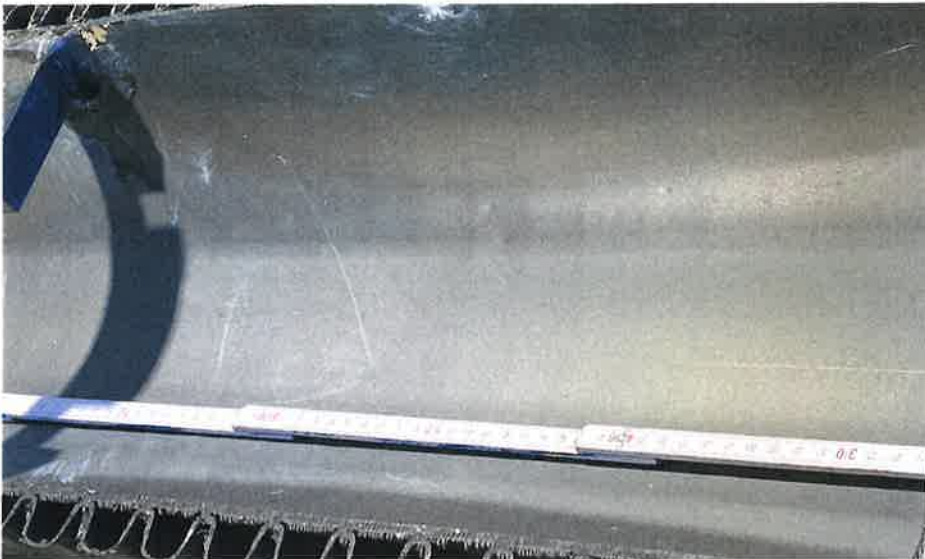
Figure 4: View into the half shell after 100,000 load cycles

The following figures 4 and 5 show the half-shell after completion of the test.

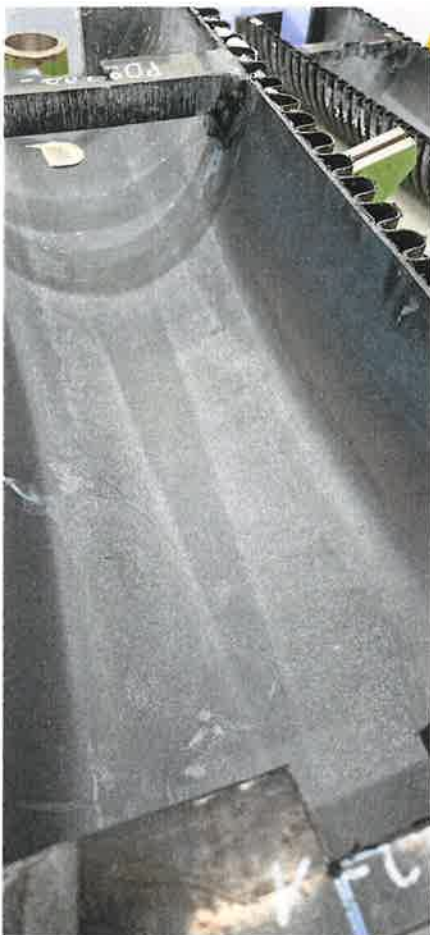
Figure 5: View into the half shell after 200,000 load cycles
