TEST REPORT: P09182-T01

Description of assignment: Abrasion tests on corrugated pipe

Specimen designation	Received on	Specimen prepared by	Description of the test specimen according to the client's specifications
IKT			
L8761-2	15.10.2024	Manufacturer	Polyethylene (PE) pipe DN/OD 315, SN 8, UNI EN 13476-3 Product name: Magnum Black

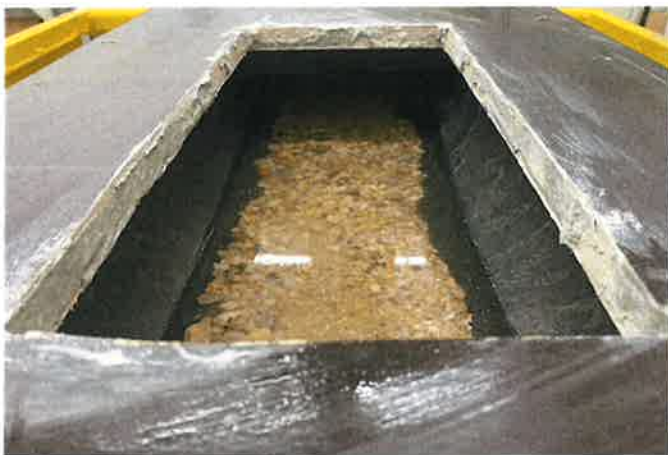
Figure 1: Sand/gravel/water mixture in the half shell before testing

With reference to DIN EN 295, Part 3, a 5,0 kg quantity of a mixture of sand and gravel (natural, non-crushed round-particled quartz gravel) is put into the pipe half-shell. Water is then added up to a depth of 38 ± 2 mm.

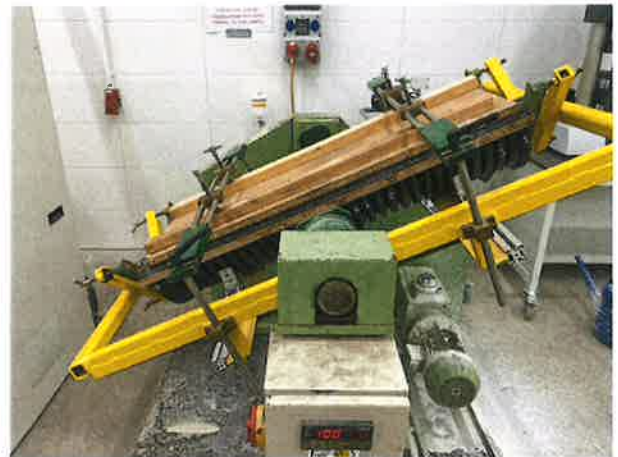
Figure 2: Testing in the Darmstadt tilting apparatus

The specimen is alternately tilted by $\pm 22.5^\circ$ in its longitudinal direction (20 cycles per minute), causing the movement of the mixture of sand, gravel and water to generate an abrasive action. The specimen is removed from the apparatus after 100,000 load cycles and the abrasion on the base line is measured. The test specimen is then reinstalled in the tilting apparatus and a further 100,000 load cycles are carried out. After a total of 200,000 load cycles, the test specimen is then removed and measured again.

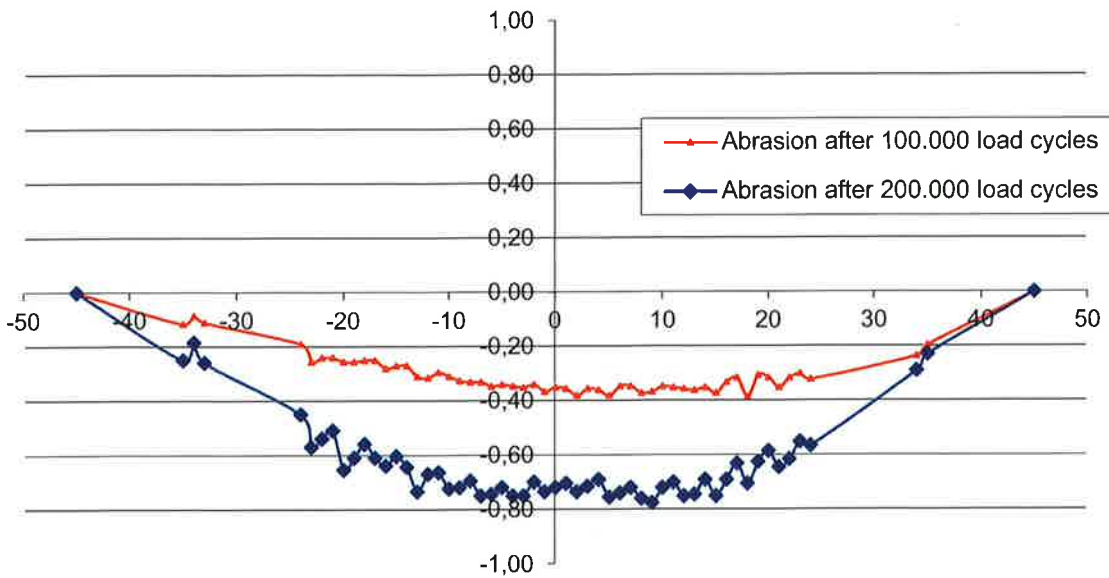
Figure 3: Abrasion after 100,000 and 200,000 load cycles

Measuring the abrasion in the base of the half-shell with a measuring gauge (accuracy better than $\pm 0.03 \text{ mm}$) using a measuring bridge shows a slight abrasion of the base. The measured values after 100,000 and 200,000 load cycles are shown in the graph in Figure 3 for the measuring points over the length of the pipe. The analysis of the measured values resulted in an average abrasion of 0.30 mm after 100,000 cycles and of 0.62 mm after 200,000 cycles (s.a. Table 1).

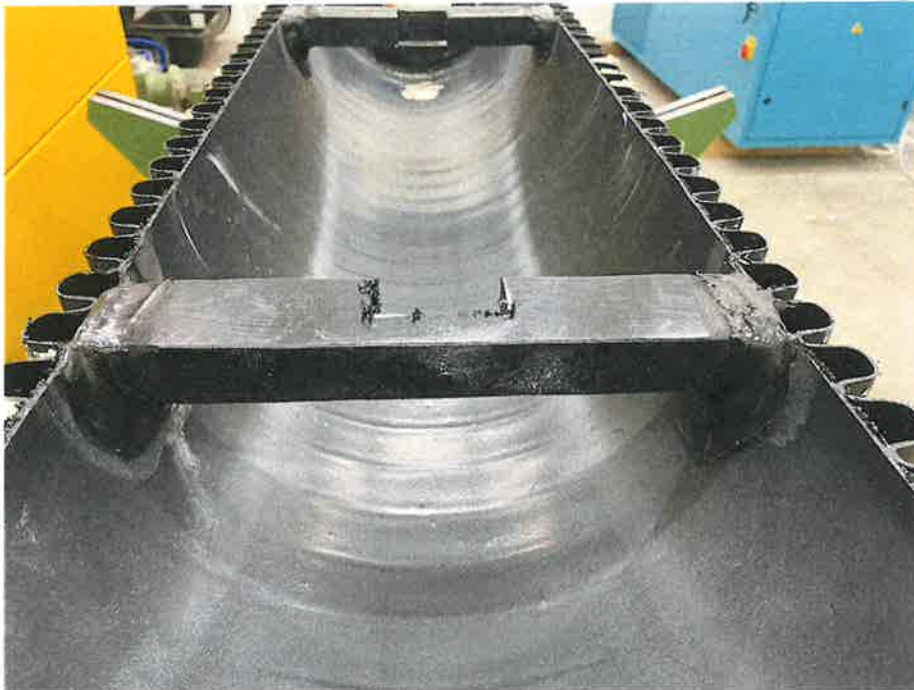
Figure 4: View into the half shell after 100,000 load cycles

The following figures 4 and 5 show the half-shell after completion of the test.

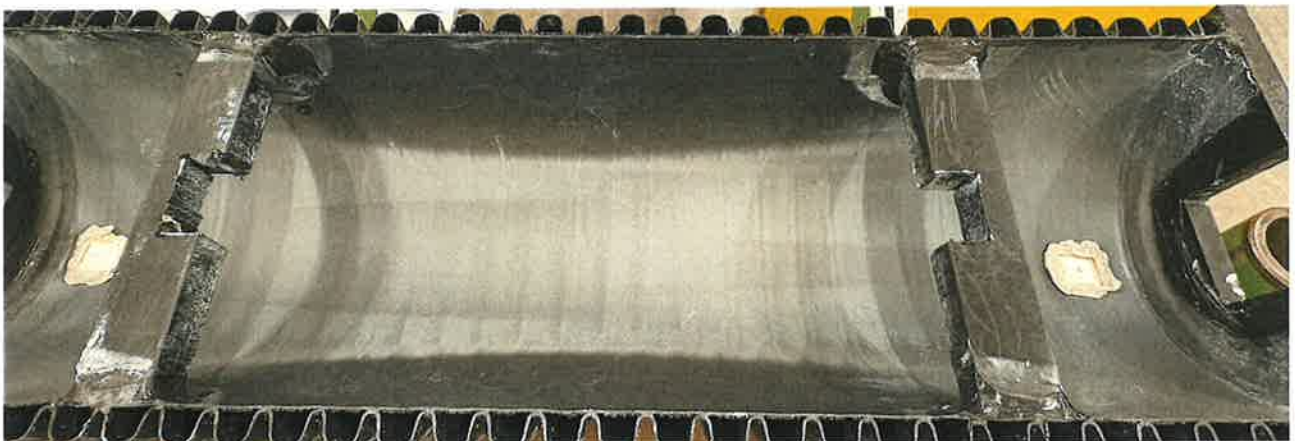
Figure 5: View into the half shell after 200,000 load cycles
